Effect of Varying Working Distances between Sandblasting Device and Composite Substrate Surface on the Repair Bond Strength

Source / Izvornik: **Materials, 2021, 14**

Article

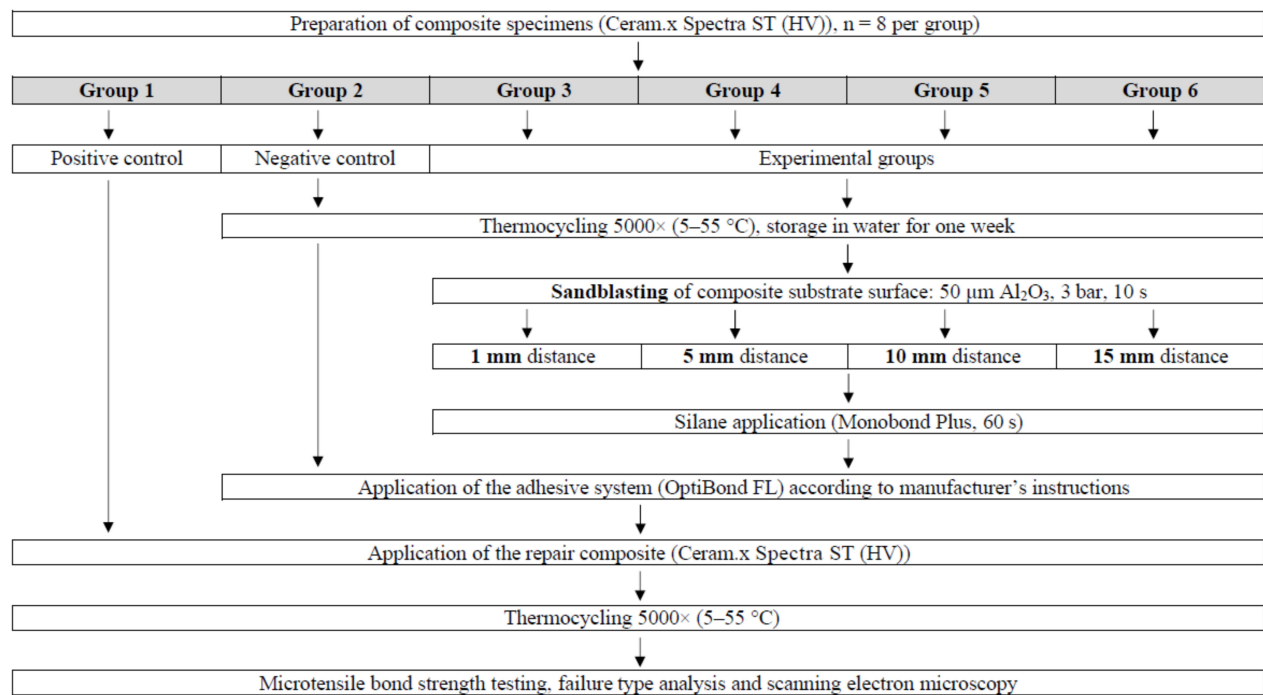
Figure 1. Experimental design.

Figure 1 illustrates the experimental design of the current study. The manufacturer details and the chemical composition of the materials used are provided in Table 1. Forty-eight specimens of a nanohybrid composite with prepolymerized fillers (Ceram.x Spectra ST (HV); Dentsply Sirona, Konstanz, Germany; shade: A4; lot No.: 1907000298) were prepared for this study. This material pertains to contemporary dental resin composites, comprising a modified methacrylate resin matrix filled with ground glass and prepolymerized filler particles. The surfaces of filler particles are typically coated with a silane coupling agent that enables their bonding to the methacrylate resin. The composite material is rendered photosensitive by camphorquinone and tertiary amine, enabling it to set on-demand in clinical work by illumination using blue light [23].

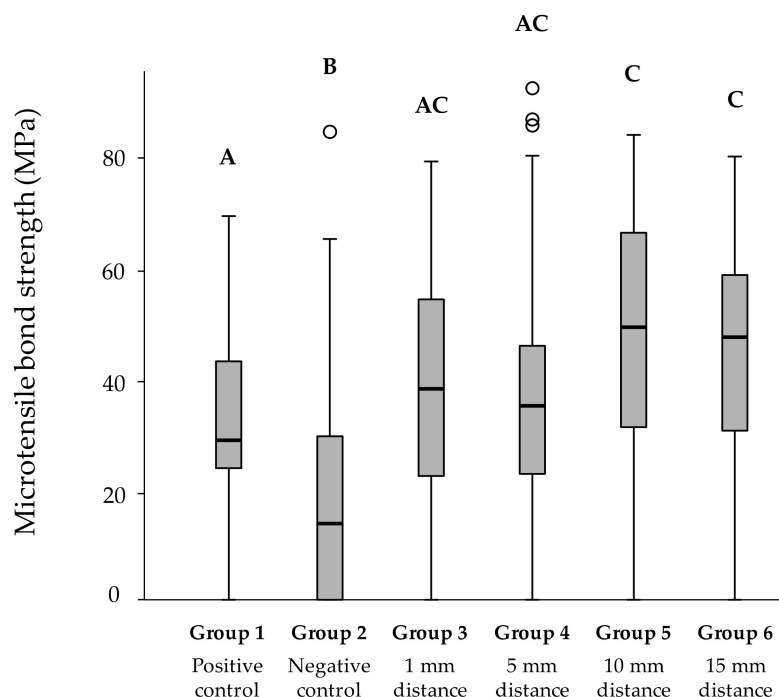
Figure 2. Microtensile repair bond strengths (MPa) of composite surfaces after sandblasting from varying working distances. Significant differences between groups are indicated by different letters ($p < 0.05$). Within each boxplot, the median is represented by a horizontal bold black line. The 25% and 75% data quartiles are shown as boxes, and the whiskers mark the $1.5 \times$ interquartile range (IQR) at the 25th and 75th percentile of each group. The outliers of groups 2 and 4 are shown as circles.

Figure 2 illustrates the microtensile repair bond strengths of the composite substrate surfaces pretreated with aluminum oxide sandblasting from the different working distances. The negative control group (group 2: $19.1\ \text{MPa} \pm 13.0$) reached the significantly lowest microtensile bond strength of all groups ($p < 0.05$). Repair bond strength of the positive control group (group 1: $32.2\ \text{MPa} \pm 4.8$) did not differ significantly from composite surfaces pretreated with aluminum oxide particles at a distance of 1 mm (group 3: $39.1\ \text{MPa} \pm 8.5$) or 5 mm (group 4: $37.8\ \text{MPa} \pm 9.5$). However, significantly higher bond strengths were found for group 5 with a sandblasting distance of 10 mm (group 5: $47.5\ \text{MPa} \pm 12.1$) and group 6 with a distance of 15 mm (group 6: $43.9\ \text{MPa} \pm 10.3$), compared to the positive control group (group 1). No significant differences in repair bond strengths could be observed within the experimental groups (groups 3–6) with working distances from 1 mm to 15 mm between composite substrate surface and tip of the sandblasting device.

Similar to other studies on repair bond strengths [13,29], in the current investigation, bond strength values between 38 MPa (group 4: 5 mm working distance) and 48 MPa (group 5: 10 mm working distance) were achieved. As these values can be considered adequate for sufficient bonding [20], our results indicate that repair procedures can be recommended regardless of the employed working distance. Additionally, silane application and application of an adhesive system may have further contributed to adhesion between the substrate and repair composite [7,11,22,27,30–32].

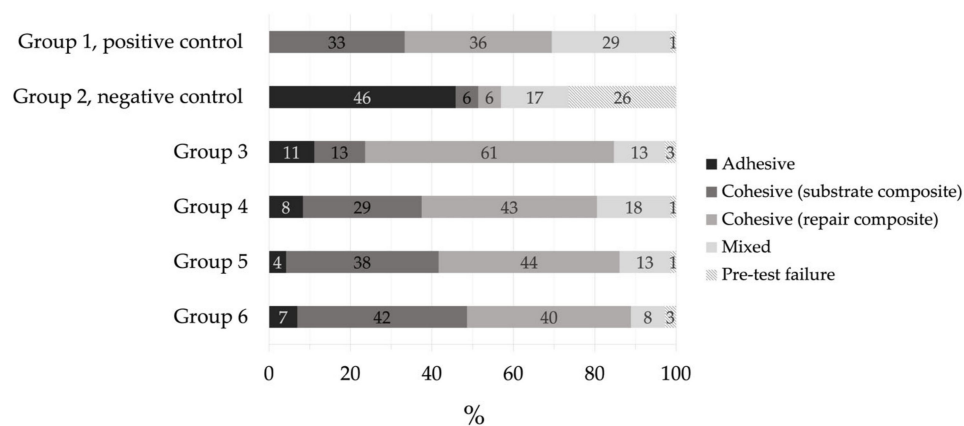
Figure 3. Percentage (%) of failure mode distribution per group.

Figure 3 depicts the failure mode distribution of all groups of the current study assessed at $25\times$ magnification with an optical light microscope. In the majority of groups (groups 1, 3–5), the most frequent failure mode was cohesive within the repair composite. In group 6, however, cohesive failures in the substrate composite were most frequently

observed. The highest percentage of pretest failures was found in the negative control group (group 2).

In the present study, cohesive failures in the repair composite were the predominant failure mode in most of the experimental groups, followed by cohesive failures in the substrate composite. The small number of adhesive failures in all groups except the negative control group (group 2) is noticeable and might be explained by degradation processes in
