Source / Izvornik: Materials, 2021, 14

# Effect of Varying Working Distances between Sandblasting Device and Composite Substrate Surface on the Repair Bond Strength

**Keywords:** composite repair; aluminum oxide sandblasting; working distance; microtensile bond strength

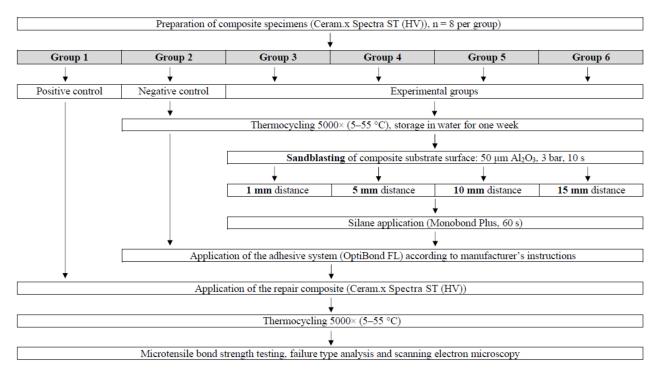
Figure 1 illustrates the experimental design of the current study. The manufacturer details and the chemical composition of the materials used are provided in Table 1. Forty-eight specimens of a nanohybrid composite with prepolymerized fillers (Ceram.x Spectra ST (HV); Dentsply Sirona, Konstanz, Germany; shade: A4; lot No.: 1907000298) were prepared for this study. This material pertains to contemporary dental resin composites, comprising a modified methacrylate resin matrix filled with ground glass and prepolymerized filler particles. The surfaces of filler particles are typically coated with a silane coupling agent that enables their bonding to the methacrylate resin. The composite material is rendered photosensitive by camphorquinone and tertiary amine, enabling it to set on-demand in clinical work by illumination using blue light [23].

Figure 1. Experimental design.

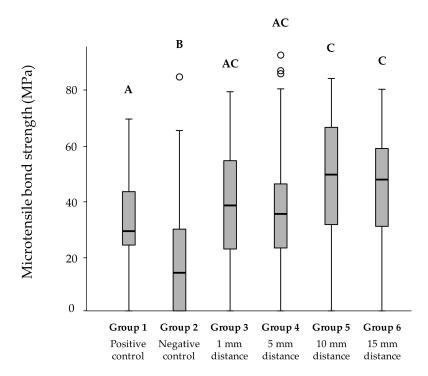
Figure 2 illustrates the microtensile repair bond strengths of the composite substrate surfaces pretreated with aluminum oxide sandblasting from the different working distances. The negative control group (group 2: 19.1 MPa  $\pm$  13.0) reached the significantly lowest microtensile bond strength of all groups (p < 0.05). Repair bond strength of the positive control group (group 1: 32.2 MPa  $\pm$  4.8) did not differ significantly from composite surfaces pretreated with aluminum oxide particles at a distance of 1 mm (group 3: 39.1 MPa  $\pm$  8.5) or 5 mm (group 4: 37.8 MPa  $\pm$  9.5). However, significantly higher bond strengths were found for group 5 with a sandblasting distance of 10 mm (group 5: 47.5 MPa  $\pm$  12.1) and group 6 with a distance of 15 mm (group 6: 43.9 MPa  $\pm$  10.3), compared to the positive control group (group 1). No significant differences in repair bond strengths could be observed within the experimental groups (groups 3–6) with working distances from 1 mm to 15 mm between composite substrate surface and tip of the sandblasting device.

**Figure 2.** Microtensile repair bond strengths (MPa) of composite surfaces after sandblasting from varying working distances. Significant differences between groups are indicated by different letters (p < 0.05). Within each boxplot, the median is represented by a horizontal bold black line. The 25% and 75% data quartiles are shown as boxes, and the whiskers mark the 1.5 × interquartile range (IQR) at the 25th and 75th percentile of each group. The outliers of groups 2 and 4 are shown as circles.

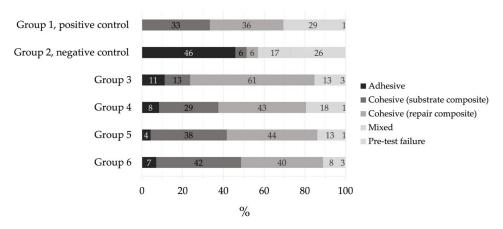
Figure 3 depicts the failure mode distribution of all groups of the current study assessed at  $25 \times$  magnification with an optical light microscope. In the majority of groups (groups 1, 3–5), the most frequent failure mode was cohesive within the repair composite. In group 6, however, cohesive failures in the substrate composite were most frequently

observed. The highest percentage of pretest failures was found in the negative control group (group 2).

Figure 3. Percentage (%) of failure mode distribution per group.

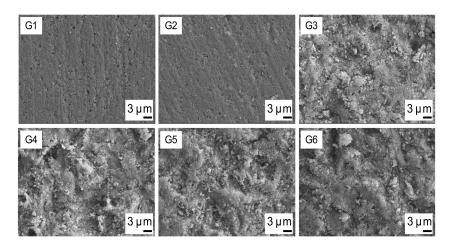
Micromorphological SEM images of the composite substrate surfaces are shown in Figure 4. In G1, the untreated composite surface is visible, whereas in G2 the aged composite surface without mechanical pretreatment is presented, both showing similar surface topography. G3–G6 of Figure 4 display the aged composite surfaces sandblasted from the varying working distances of 1 mm (G3), 5 mm (G4), 10 mm (G5), and 15 mm (G6). They exhibit similar surface structures among themselves, but they display a more irregular topography than the untreated positive control group (G1) and the solely aged composite surface of the negative control (G2). In addition, analysis by energy dispersive X-ray

**Figure 4.** Scanning electron microscopy (SEM) images  $(5000 \times \text{magnification})$  of the composite surfaces of all groups. G1: positive control group; G2: negative control group; G3–G6: composite substrate surfaces sandblasted from working distances of 1 mm (G3), 5 mm (G4), 10 mm (G5), and 15 mm (G6).

Correlating with the achieved repair bond strengths, SEM images showed comparable irregular surfaces after sandblasting, exhibiting similar micro-retentive patterns [21].
