# Effect of Varying Working Distances between Sandblasting Device and Composite Substrate Surface on the Repair Bond Strength

Source / Izvornik: **Materials, 2021, 14**

**Journal article, Published version**

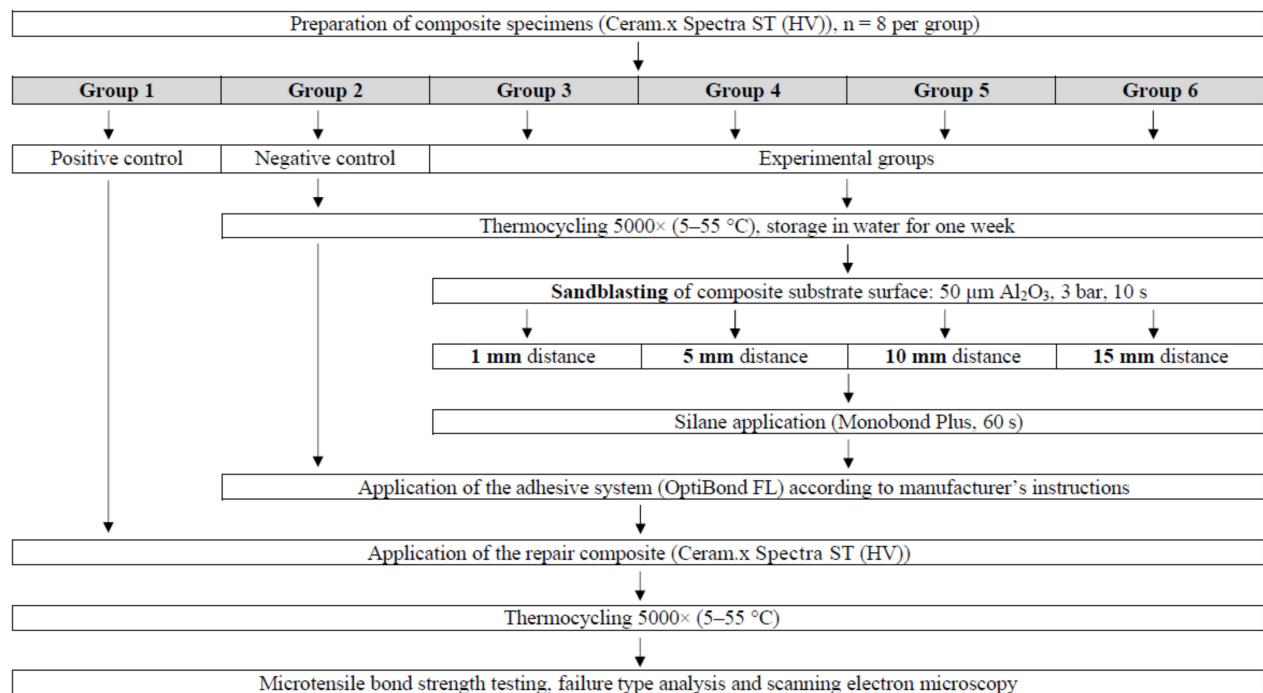
Figure 1. Experimental design.

Figure 1 illustrates the experimental design of the current study. The manufacturer details and the chemical composition of the materials used are provided in Table 1. Forty-eight specimens of a nanohybrid composite with prepolymerized fillers (Ceram.x Spectra ST (HV); Dentsply Sirona, Konstanz, Germany; shade: A4; lot No.: 1907000298) were prepared for this study. This material pertains to contemporary dental resin composites, comprising a modified methacrylate resin matrix filled with ground glass and prepolymerized filler particles. The surfaces of filler particles are typically coated with a silane coupling agent that enables their bonding to the methacrylate resin. The composite material is rendered photosensitive by camphorquinone and tertiary amine, enabling it to set on-demand in clinical work by illumination using blue light [23].

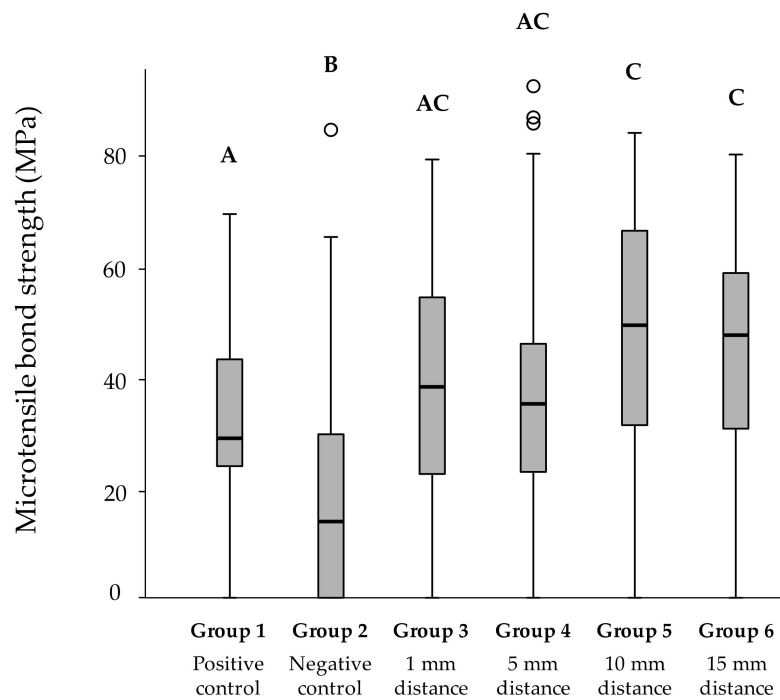
**Figure 2.** Microtensile repair bond strengths (MPa) of composite surfaces after sandblasting from varying working distances. Significant differences between groups are indicated by different letters ( $p < 0.05$ ). Within each boxplot, the median is represented by a horizontal bold black line. The 25% and 75% data quartiles are shown as boxes, and the whiskers mark the  $1.5 \times$  interquartile range (IQR) at the 25th and 75th percentile of each group. The outliers of groups 2 and 4 are shown as circles.

Figure 2 illustrates the microtensile repair bond strengths of the composite substrate surfaces pretreated with aluminum oxide sandblasting from the different working distances. The negative control group (group 2:  $19.1\ \text{MPa} \pm 13.0$ ) reached the significantly lowest microtensile bond strength of all groups ( $p < 0.05$ ). Repair bond strength of the positive control group (group 1:  $32.2\ \text{MPa} \pm 4.8$ ) did not differ significantly from composite surfaces pretreated with aluminum oxide particles at a distance of 1 mm (group 3:  $39.1\ \text{MPa} \pm 8.5$ ) or 5 mm (group 4:  $37.8\ \text{MPa} \pm 9.5$ ). However, significantly higher bond strengths were found for group 5 with a sandblasting distance of 10 mm (group 5:  $47.5\ \text{MPa} \pm 12.1$ ) and group 6 with a distance of 15 mm (group 6:  $43.9\ \text{MPa} \pm 10.3$ ), compared to the positive control group (group 1). No significant differences in repair bond strengths could be observed within the experimental groups (groups 3–6) with working distances from 1 mm to 15 mm between composite substrate surface and tip of the sandblasting device.

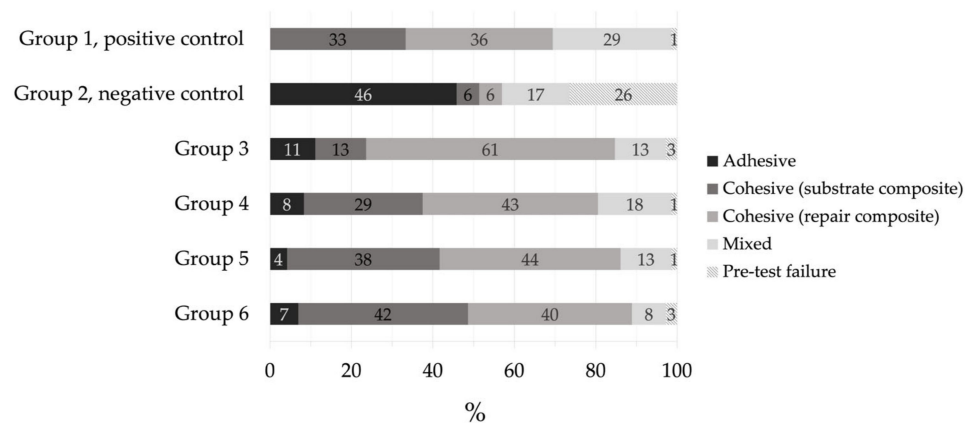
**Figure 3.** Percentage (%) of failure mode distribution per group.

Figure 3 depicts the failure mode distribution of all groups of the current study assessed at  $25\times$  magnification with an optical light microscope. In the majority of groups (groups 1, 3–5), the most frequent failure mode was cohesive within the repair composite. In group 6, however, cohesive failures in the substrate composite were most frequently

observed. The highest percentage of pretest failures was found in the negative control group (group 2).
